WL-TR-97-4054

**PROCEEDINGS OF THE 1996 USAF
AIRCRAFT STRUCTURAL INTEGRITY
PROGRAM CONFERENCE**

Dr. Hal Burnside*

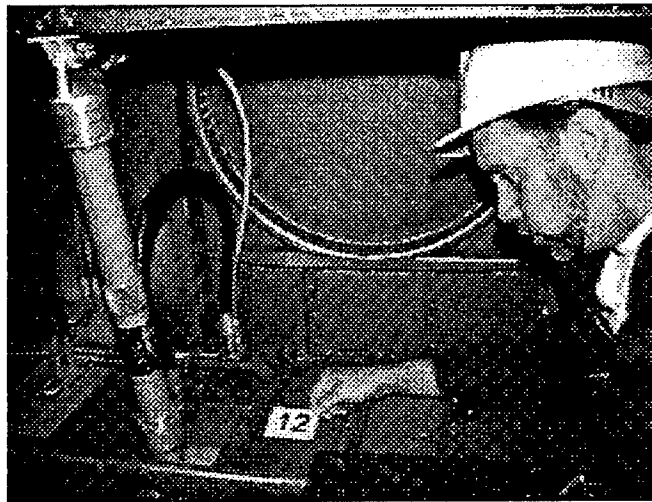
Identifying the Repair

Each repair is identified by a number. Shown here is an engineer numbering a structural repair in the hayloft area of the aircraft. Some repairs are standard and have already been defined with standard repair numbers. These repairs are not photographed.

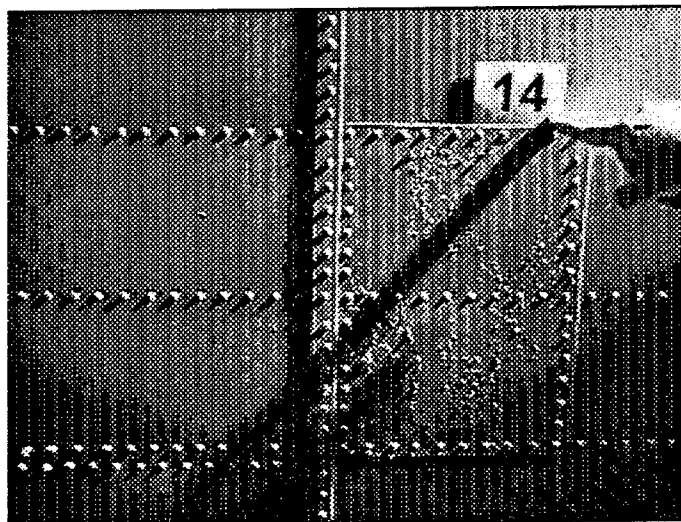
Photo of Repair

Shown on this slide is a doubler installed on the hayloft floor.

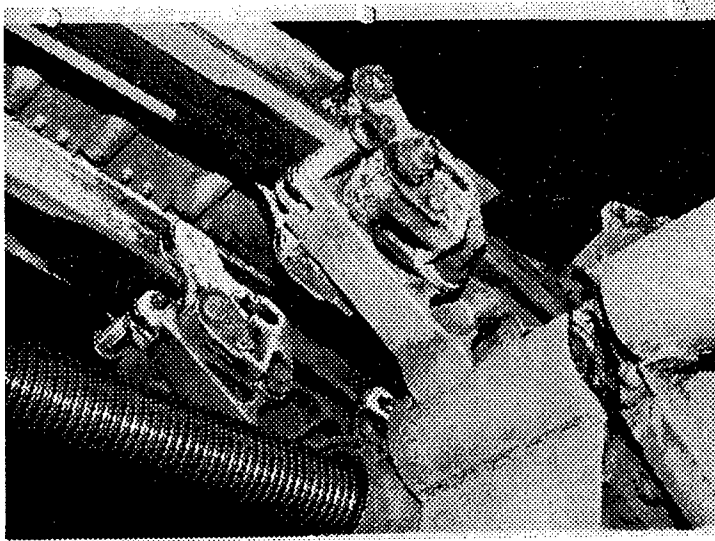
System Discrepancy

This photograph shows two system items, the flap track rib with mild corrosion and the flap jackscrew. Also shown is a secondary structure item, a flap carriage containing moderate corrosion.

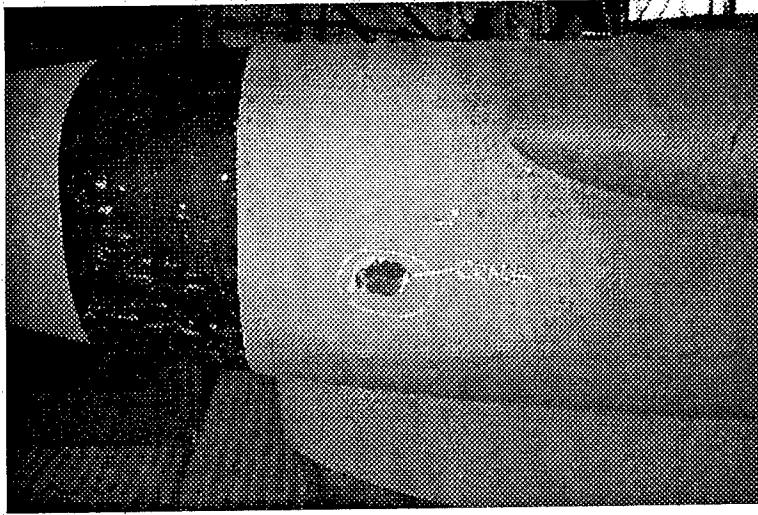
Secondary Structure Discrepancy

The above slide shows a large puncture/crack in the secondary structure of the bullet on the horizontal stabilizer.

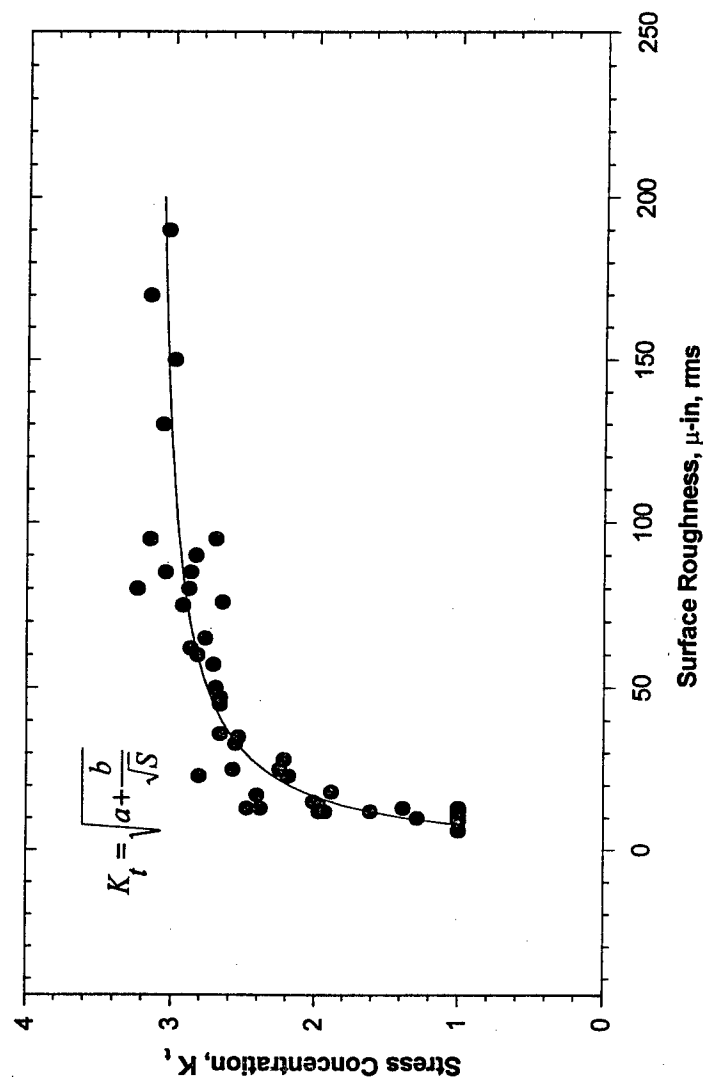
K_t as a Function of Surface Roughness

The data was generated in an effort by Clayton L. Harmsworth, Wright Laboratory, ASD Technical Report 61-121, July 1961

1. 85 rotating beam specimens were used in the program.
2. The corrosive solution was a 20% (by weight) salt-spray at 95F.
3. The unexposed specimens were polished to a 5-10 m-in, rms surface roughness.

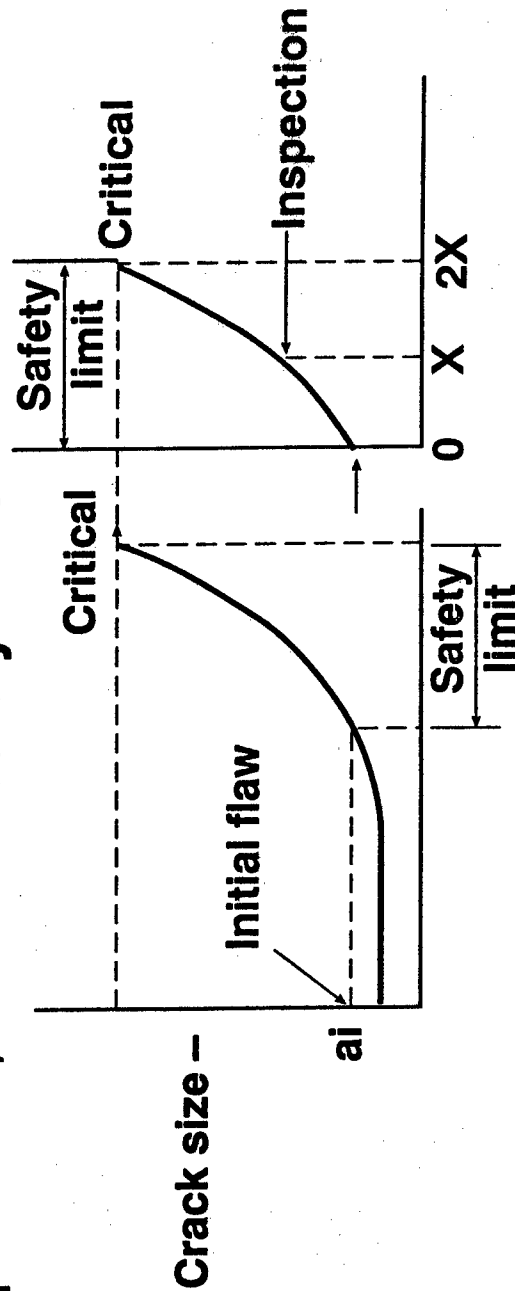
INSPECTION INTERVAL

- Assume initial flaws at critical locations (depends on inspection capabilities)
- Determine life to critical crack size (safety limit)
- Inspect at $1/2 \rightarrow 1X$ safety limit

Usage – (hrs/missions) Usage – (hrs/missions)

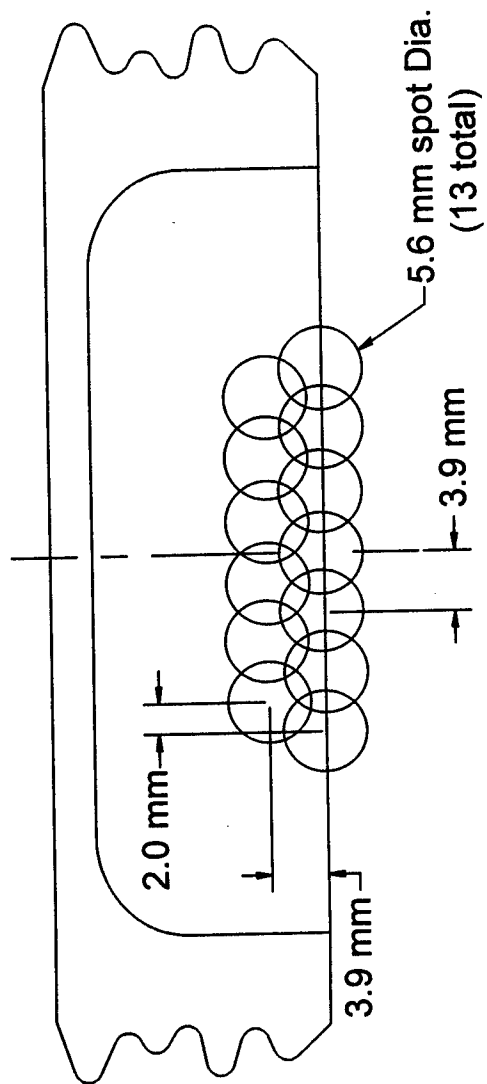
LSP Spot Pattern

- 3 x 200 J/cm² (50 J pulse in each side)
- 30% spot overlap
- 5.6 mm circular spot

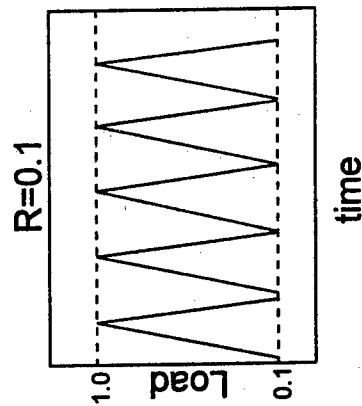
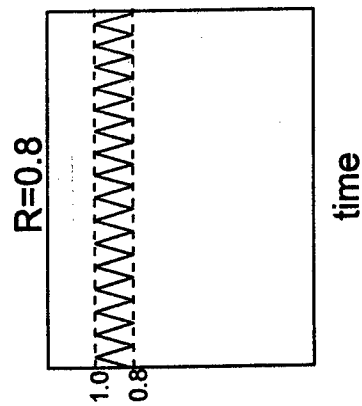
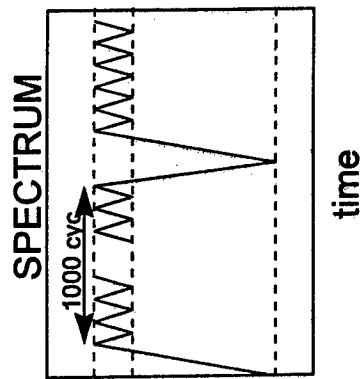
LOADING CONDITIONS

- 3-point Flexural
- Room Temperature
- 50-60 Hz (sinusoidal)

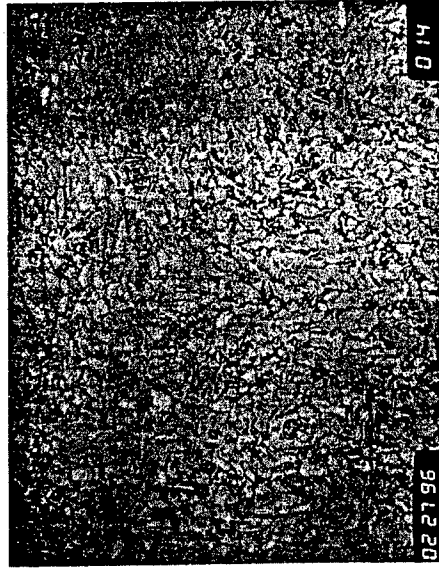
- Both microstructures consist of equiaxed grains of α and transformed β (Widmanstätten α)

Laser-shock peened

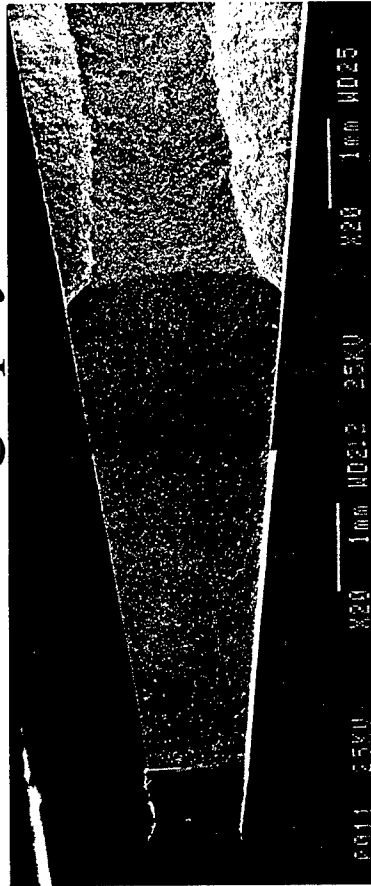
Baseline - R=0.1

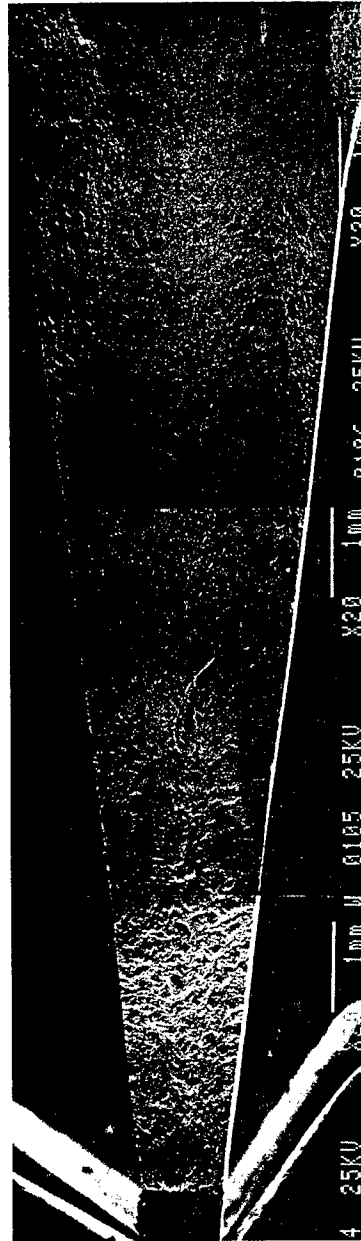
LSP - R=0.1

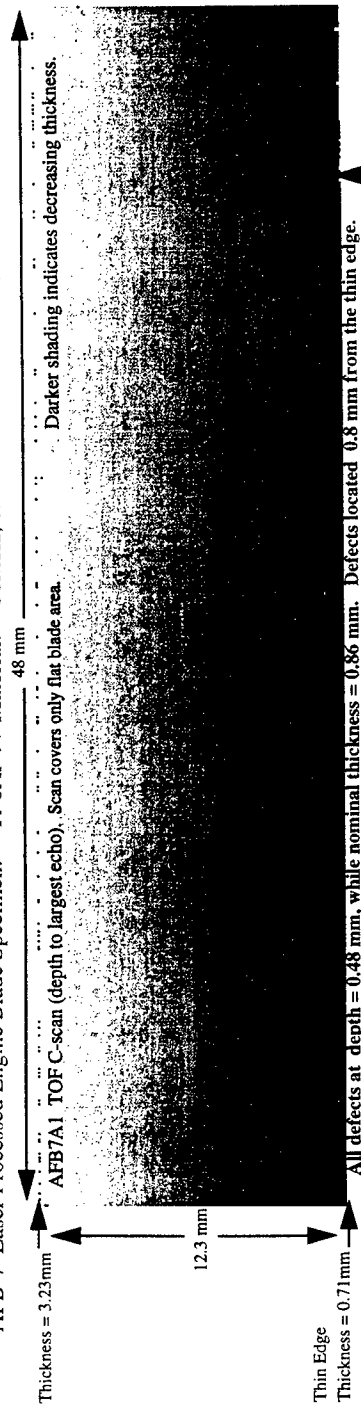
AFB-7 Laser Processed Engine Blade Specimen. Ti-6Al-4V Material. 50MHz, 0.5" Focused Transducer, 3-5-96 WL/MILLP

AFB7A2 Peak-to-Peak Amplitude C-scan of the TOF echo

- ◆ **As-received and LSP test samples, and fan blade which had been LSP'd were C-Scanned for flaws**
- ◆ **LSP sample was found to contain delaminations at the mid-plane of the thickness**
 - **The as-received specimen had none**
 - **Because of the curvature in the blade, proper inspection was impossible**

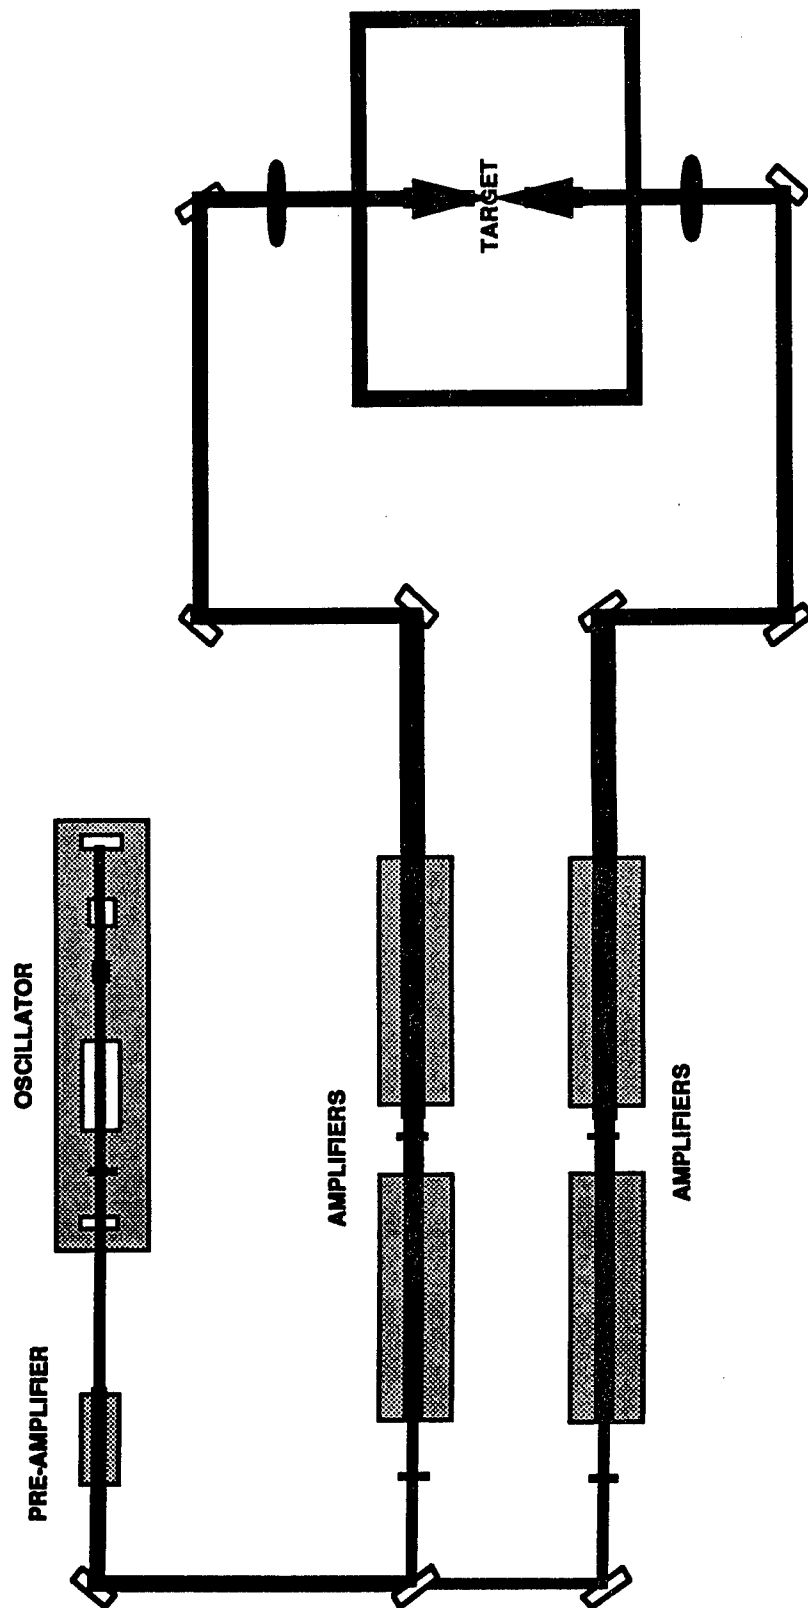
Typical LSP System for Airfoils

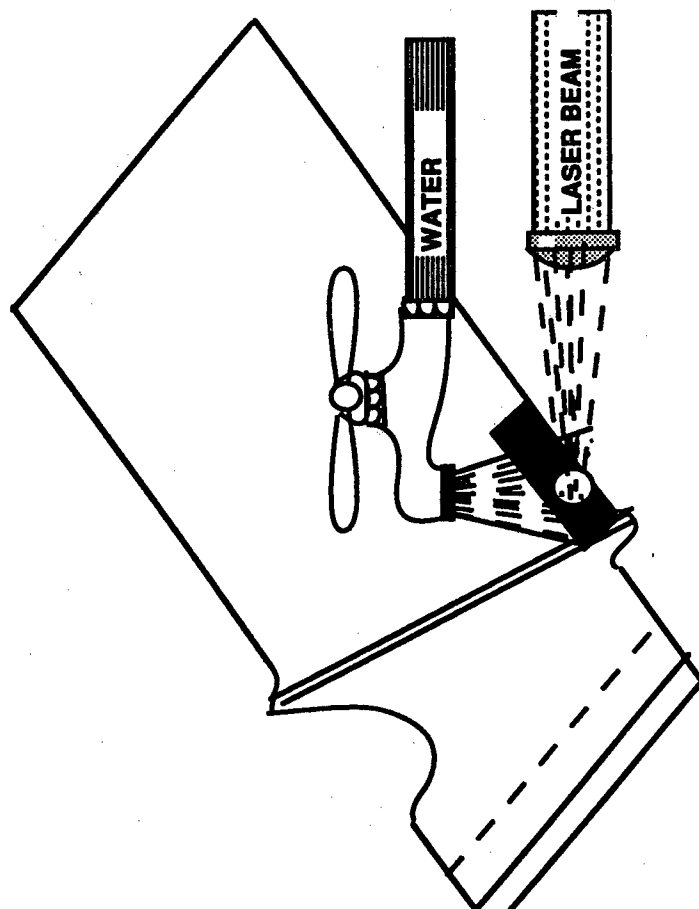
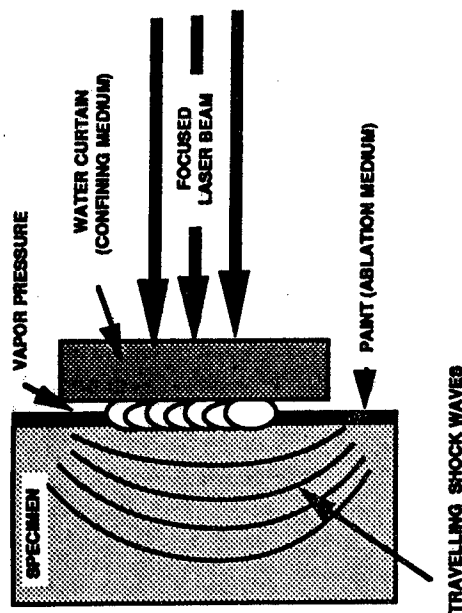
LSP CONCEPT

Residual stresses are generated by traveling shock waves created by rapidly expanding vapors due to absorption of high energy, ≈ 20 nanosecond laser pulses. Paint protects surface and water directs shock waves into the material.

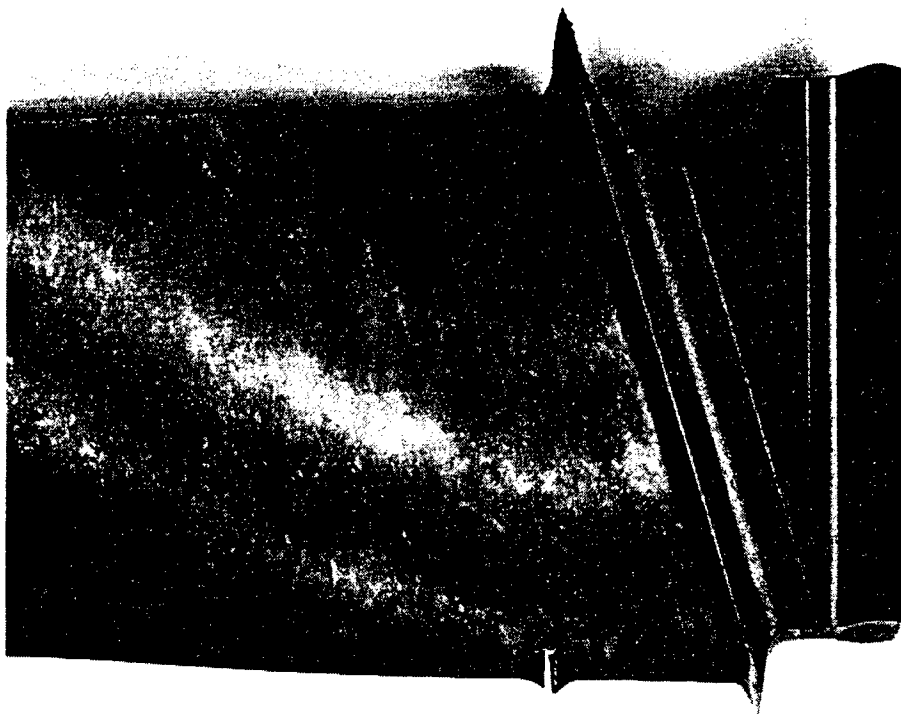
0.25" Deep Side Shear Damage With Chisel

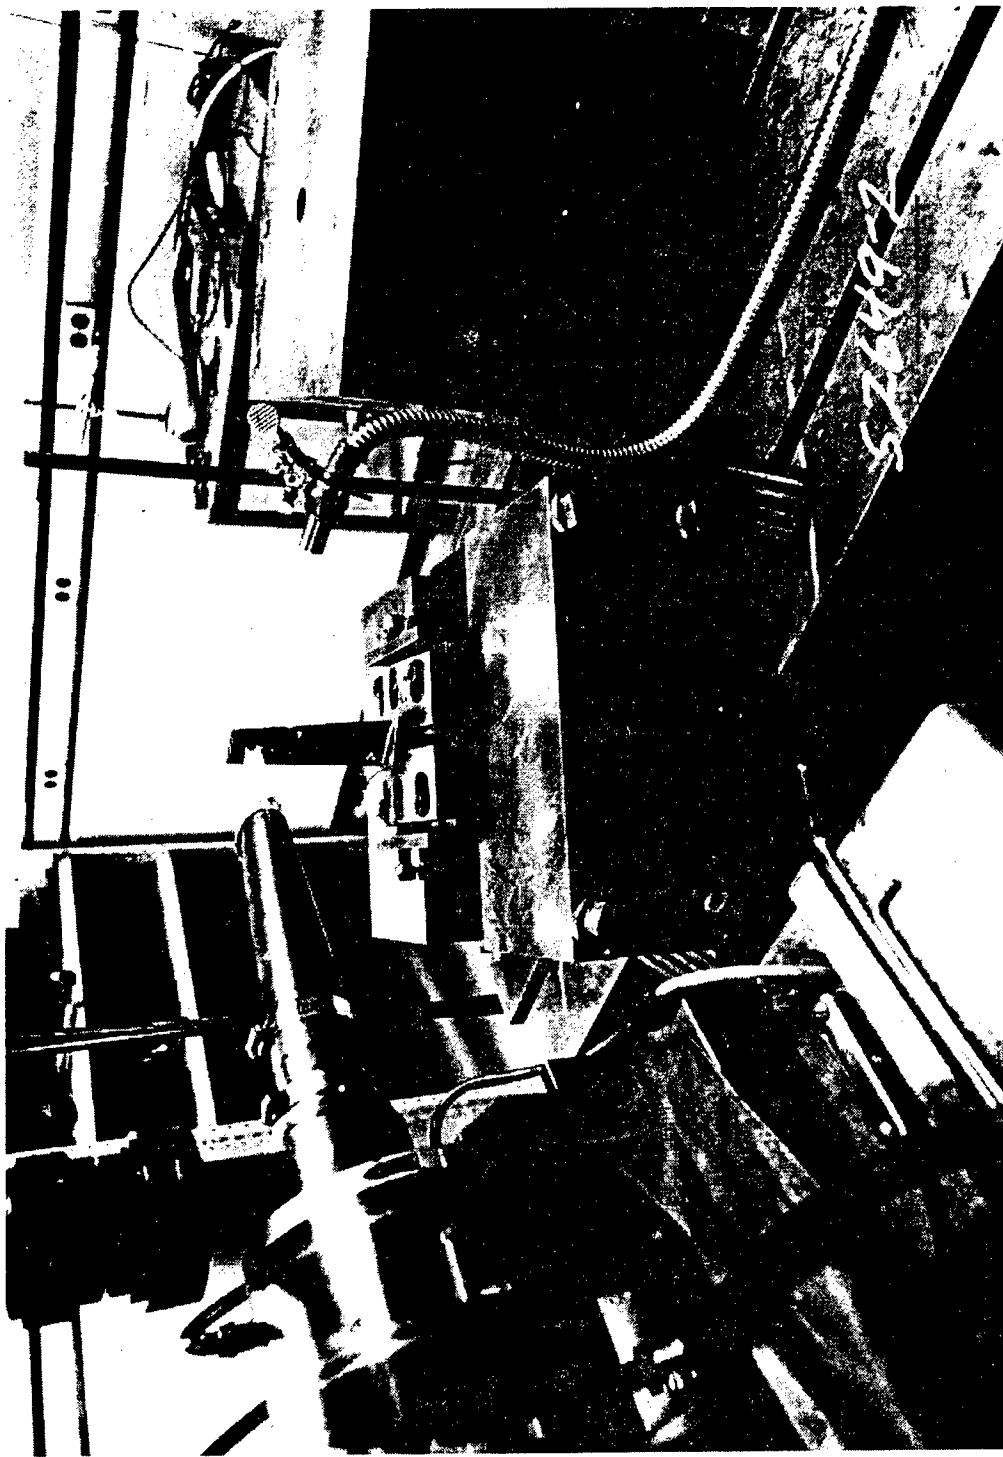
SIREN HCF TEST FACILITY

Flexural Blade Specimen Torsional Blade Specimen

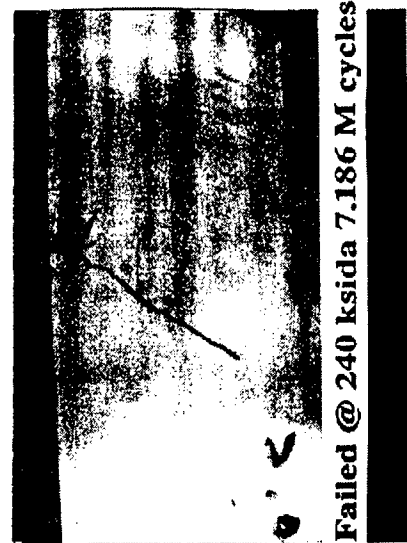
S/N 37690
FAILURE AT 240 KSI DA

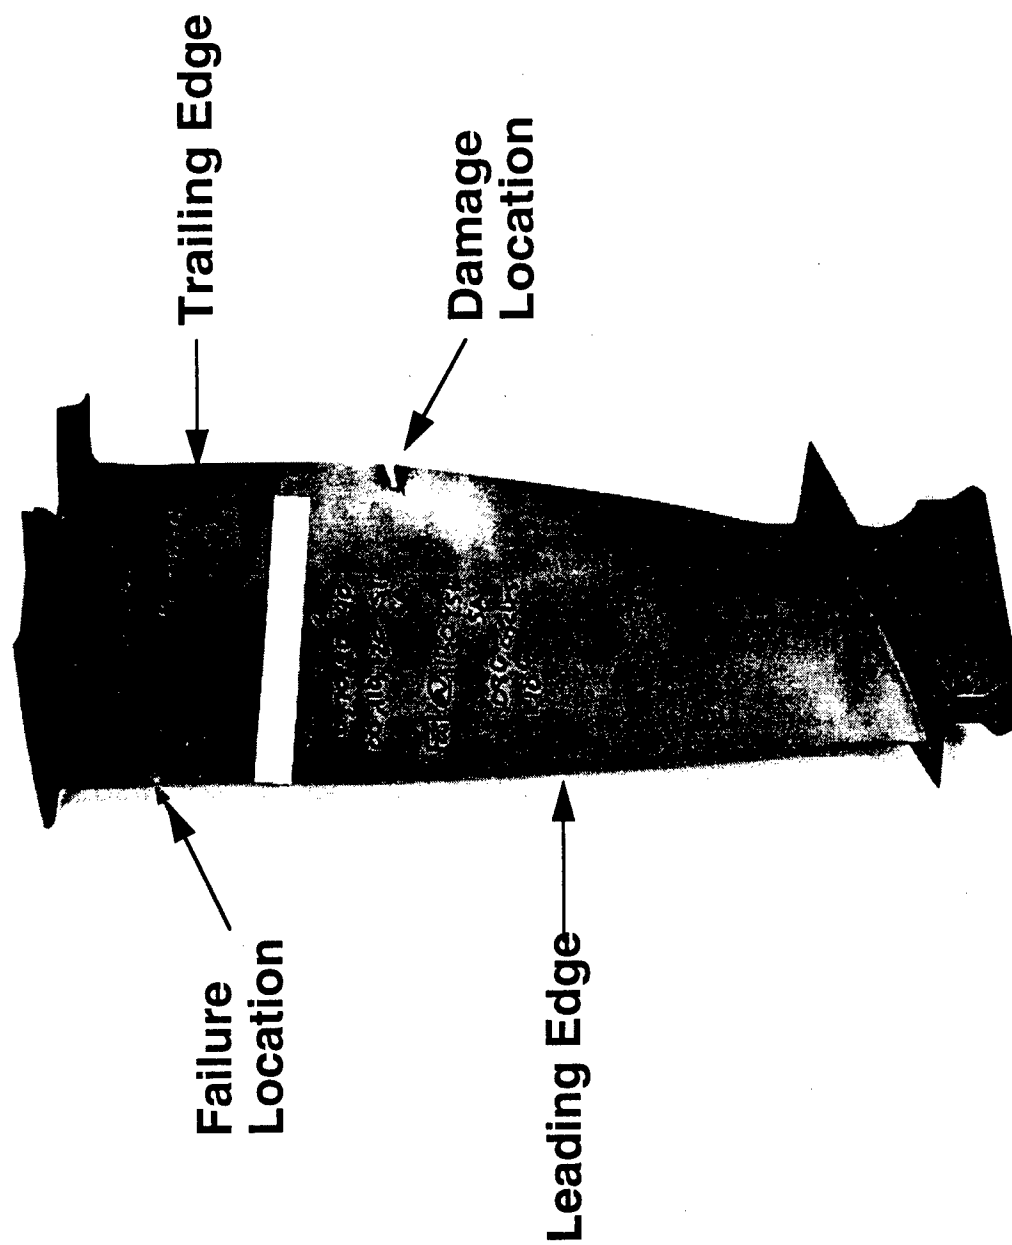
TYPICAL LSP FAN BLADE HCF TEST RESULTS (Torsional Mode with 1/4" side shear damage)

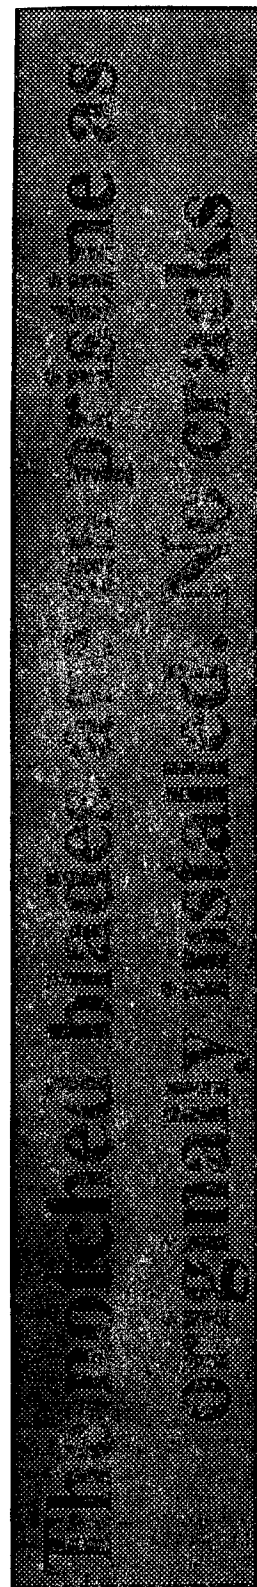
NOTCHED BLADE FOR ENGINE TEST

- Engine test was done at Arnold Engineering Development Center in Tennessee
- Two notched blades with 0.125" deep side shear damage were installed in the engine
- Maximum Maneuver distortion screen was installed to excite critical resonance conditions
- Ten Accels and Decels prior to resonance test
- Held for 30 minutes at peak resonance near max. power
- Five Accels and Decels before the engine was shut down

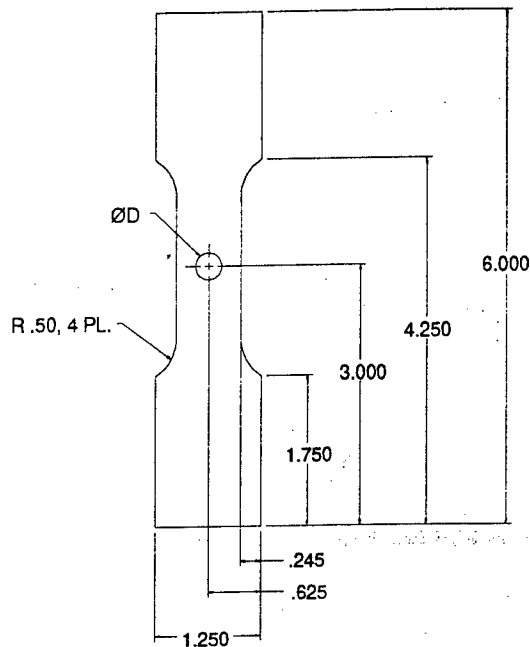
Figure 8
Fatigue Specimen Design

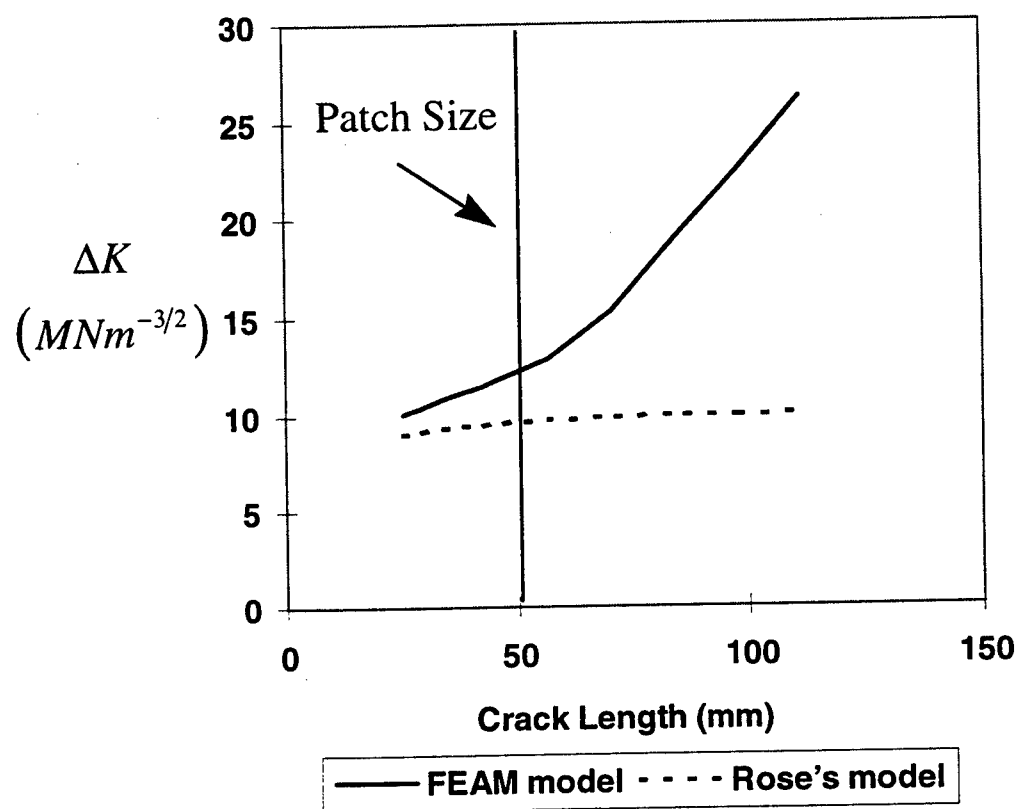
Figure 6 The stress intensity factor as a function of crack length for FEAM and Rose's models.

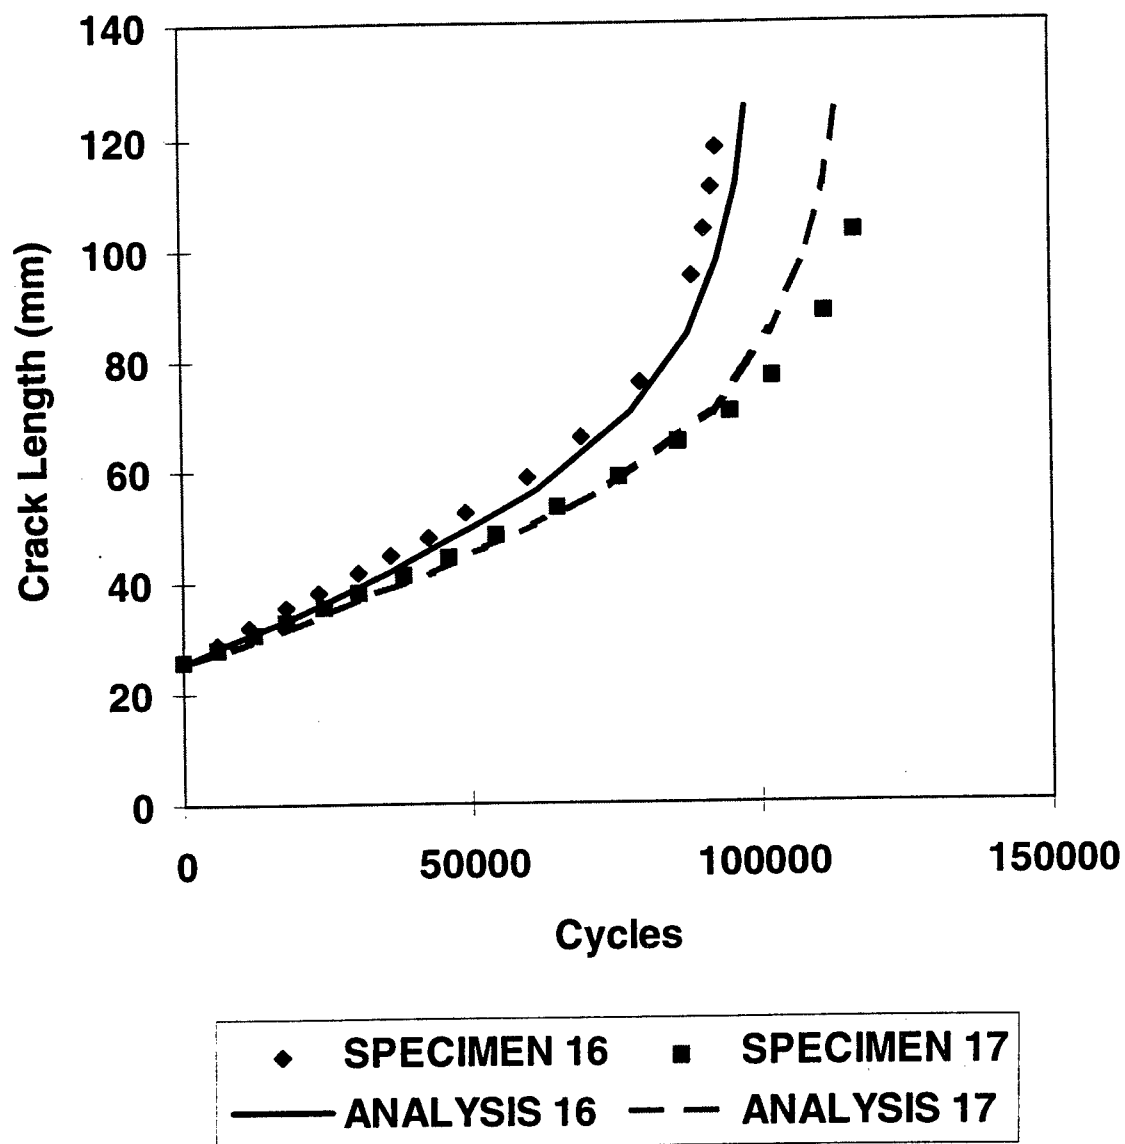
Figure 10 Comparison of numerical result with experimental data for Crack Disbond (CD).

In the next analysis, the fatigue crack growth of specimens with a center disbond is evaluated. Specimen 16 has a disbond area of 10% and Specimen 17 has a disbond area of 5%. Figure 10 shows that the fatigue responses predicted with FEAM agree quite well with the experimental data from Specimen 16 and 17. The predicted number of cycles to failure for Specimens 16 and 17 are 99,411 and 114,707 respectively. These results correspond well with the experimental data where the number of cycles to failure

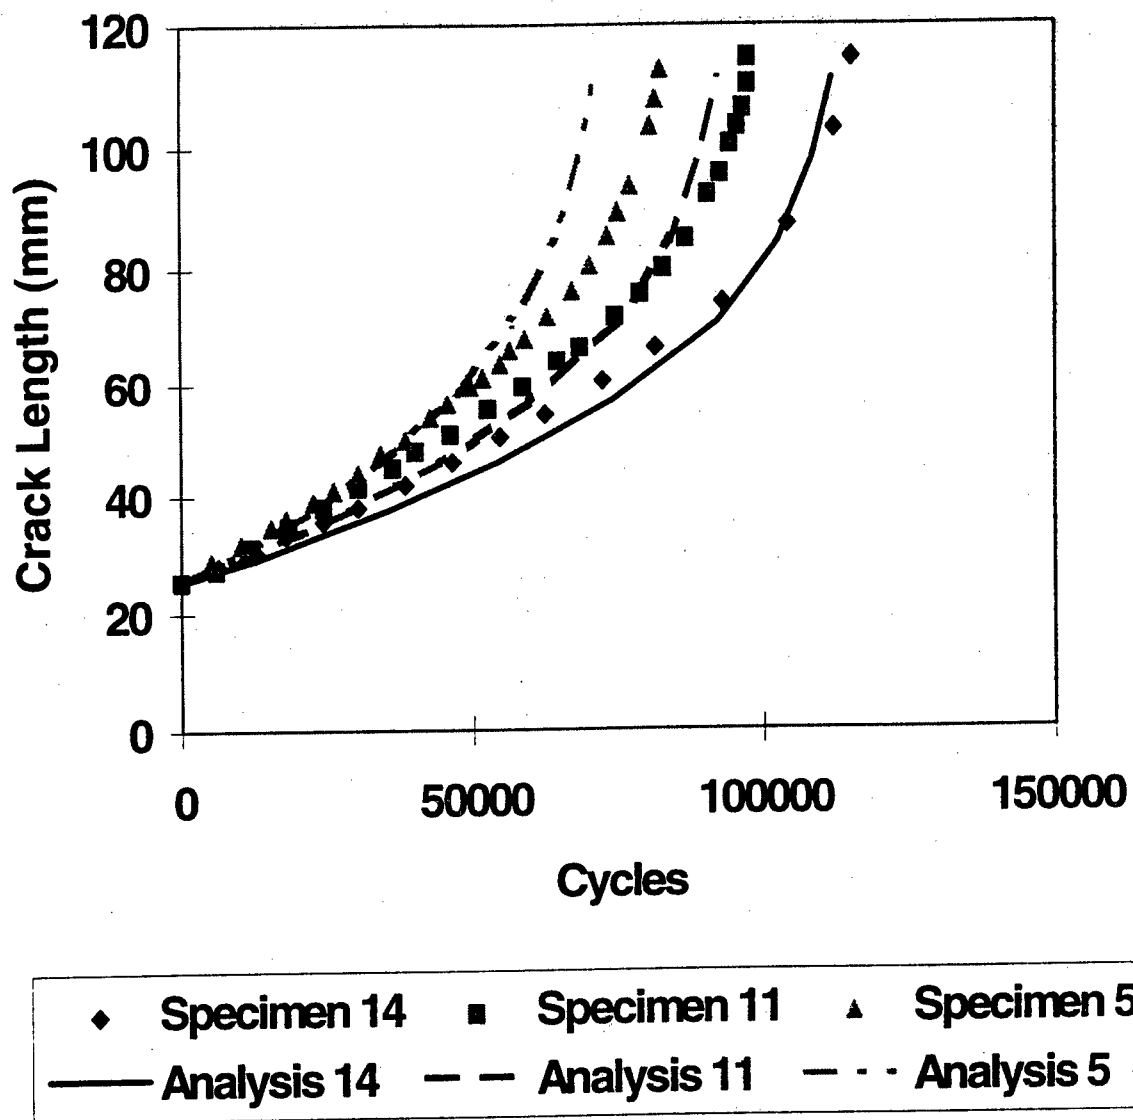
Figure 11 Comparison of numerical result with experimental data for full width disbond (FWD).

Four full width disbond (FWD) specimens have been investigated by Denny; Specimens 4, 5, 11 and 14. These specimens have disbond areas of 20% (for Specimen 4 & 5), 10% (for Specimen 11), and 5% (for Specimen 14). The numerical analysis seems to provide good correlation with the experiment when the disbond area is small. However, for specimens with larger disbond area, the numerical solution seems to over predict the reduction in the fatigue life as shown in Figure 11. The predicted number of cycles to failure for Specimens 4, 5, 11 and 14 are 73,404, 73,404, 95,048 and 115,108 respectively. These results correspond with the experimental data where the number of cycles to failure for Specimens 4, 5, 11 and 14 are found to be 86,995, 82,324, 97,278 and 114,423 respectively.

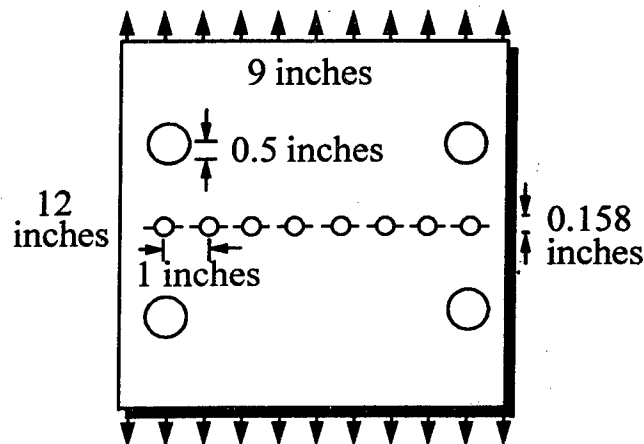
Modeling of Stiffener Effect Using Four Corner Holes (Case II)

Crack Growth Equation

$$da/dN = c (\Delta K - \Delta K_{th})^m$$

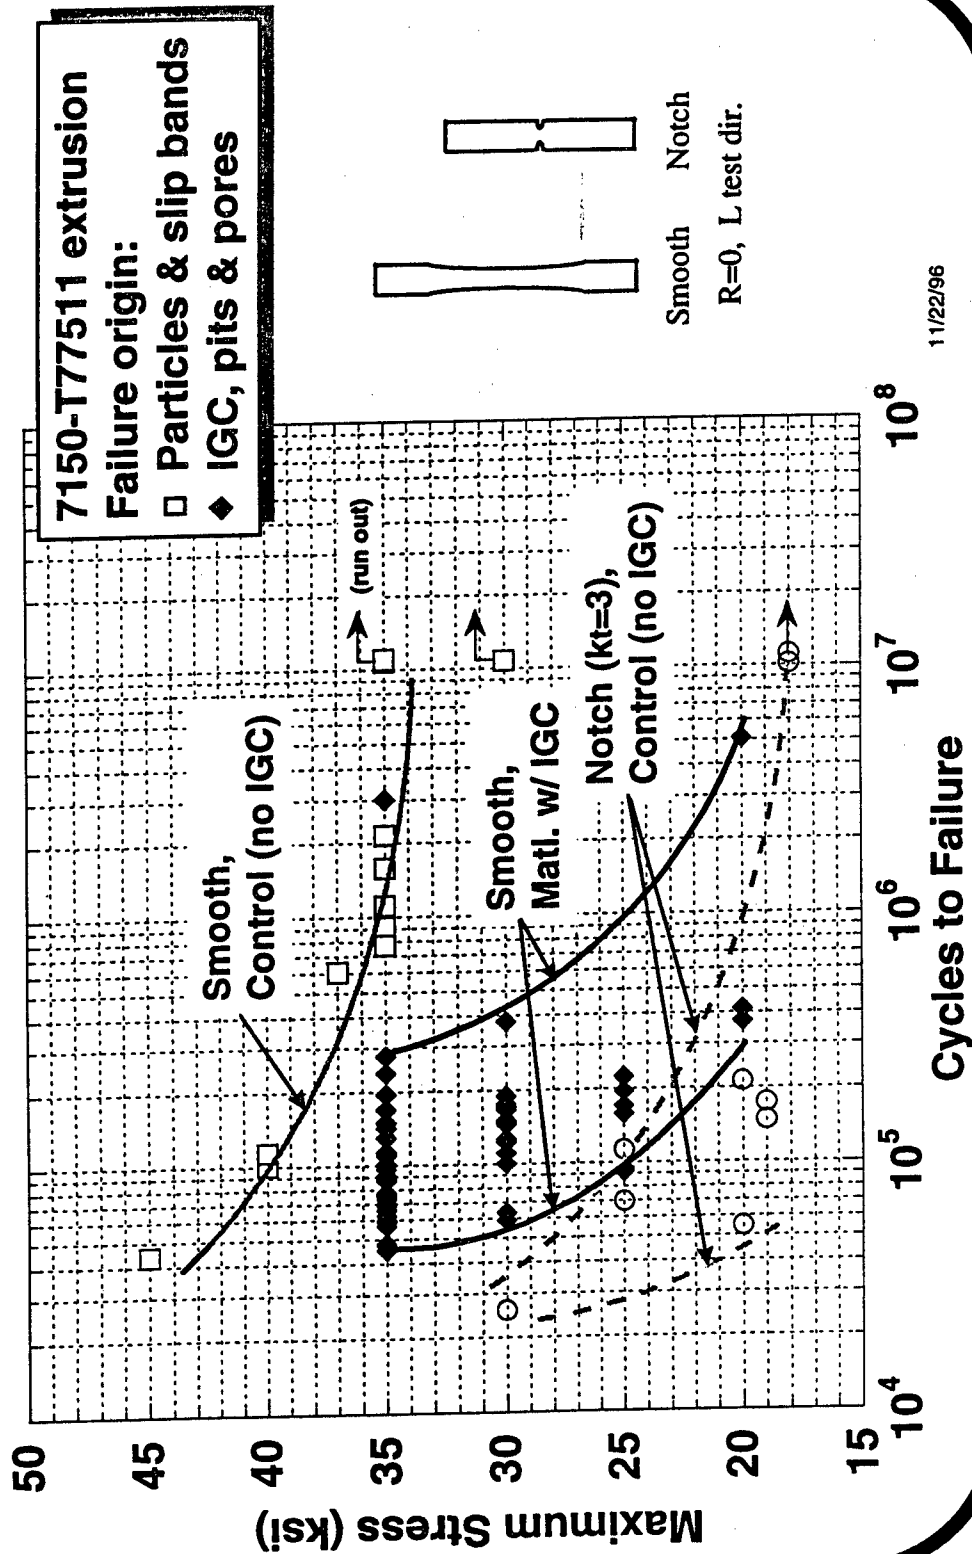
Fatigue performing links with crack originating microfeature type.

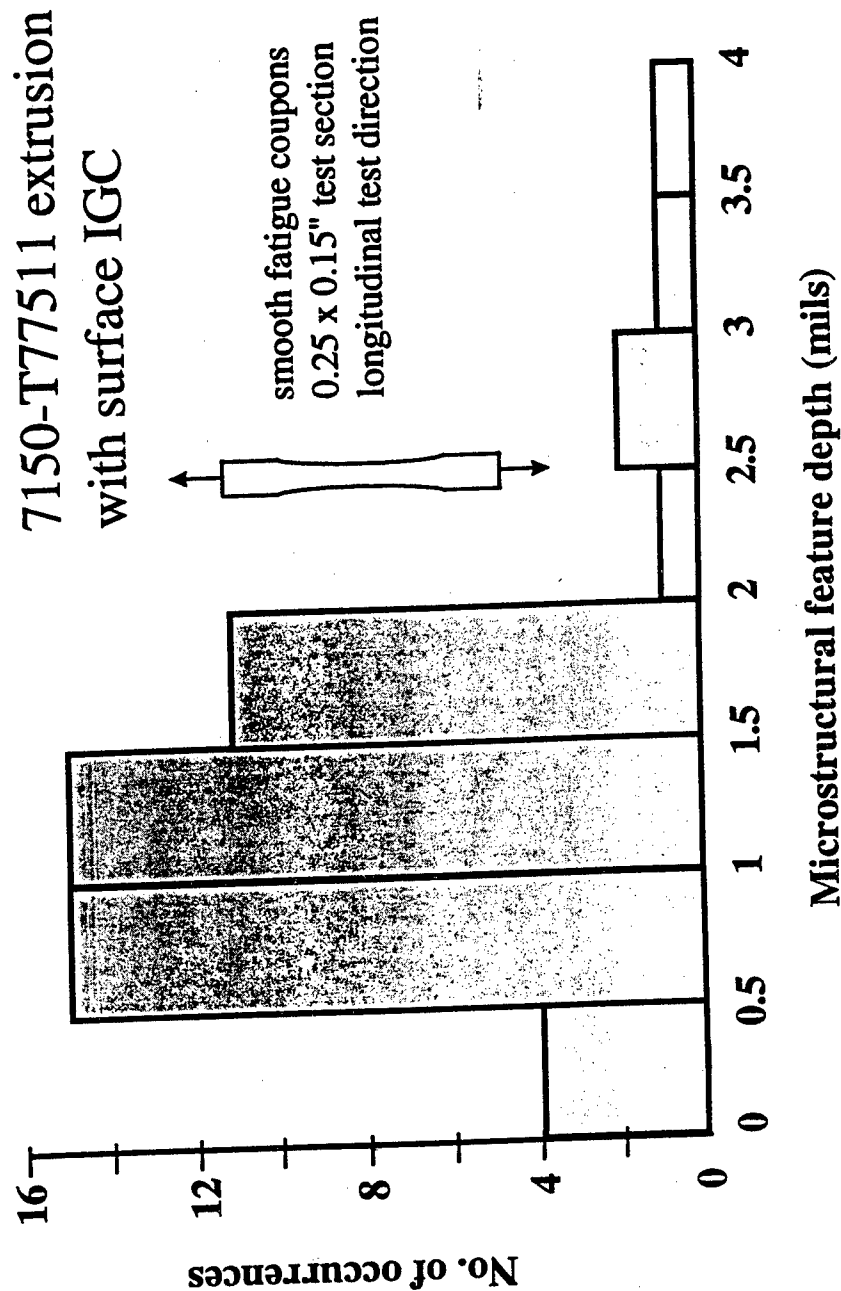
Typical crack originating microfeatures were < 2 mils, but depths to 4 mils were found.

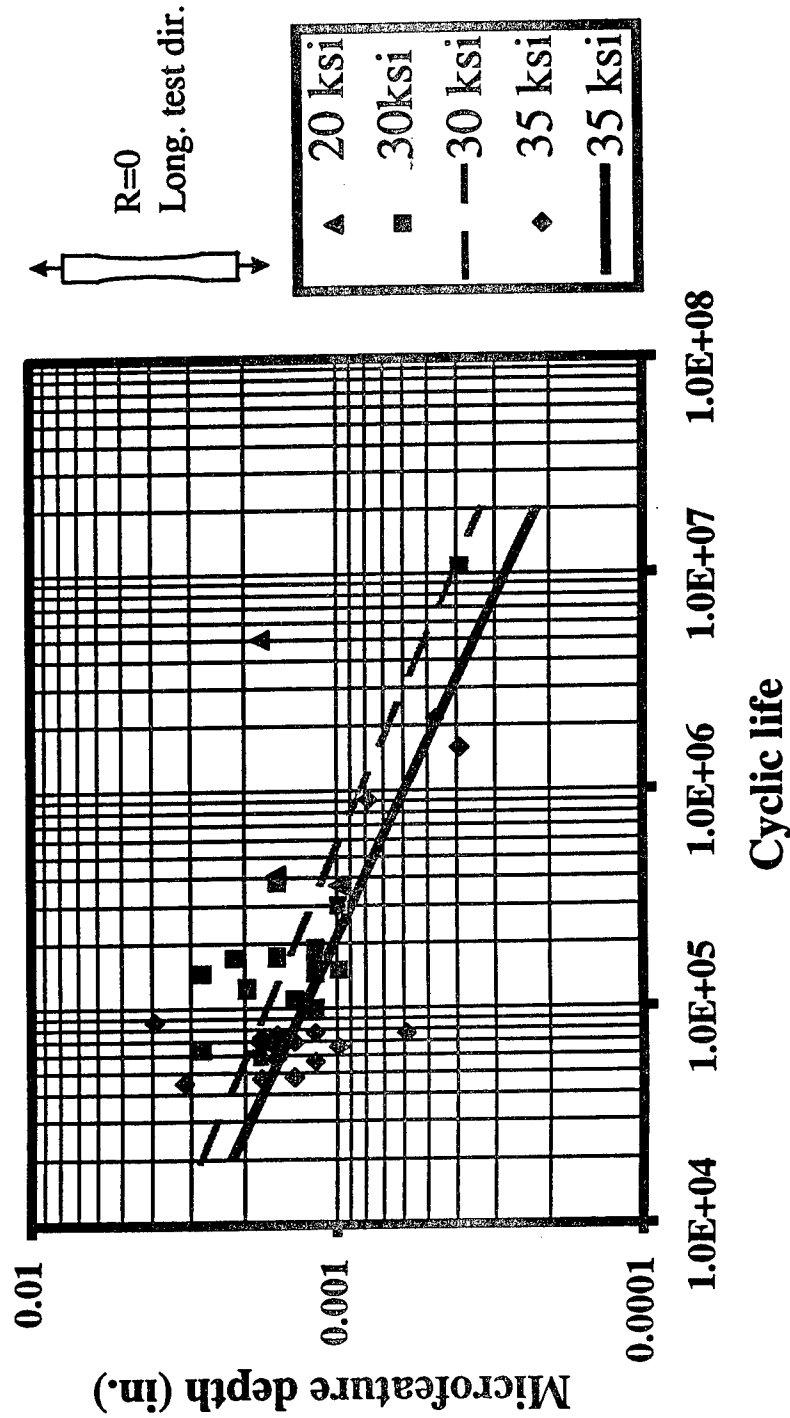
Cyclic performance correlates with scale of the life-limiting microfeature.

7150-T77511 extrusion with surface IGC

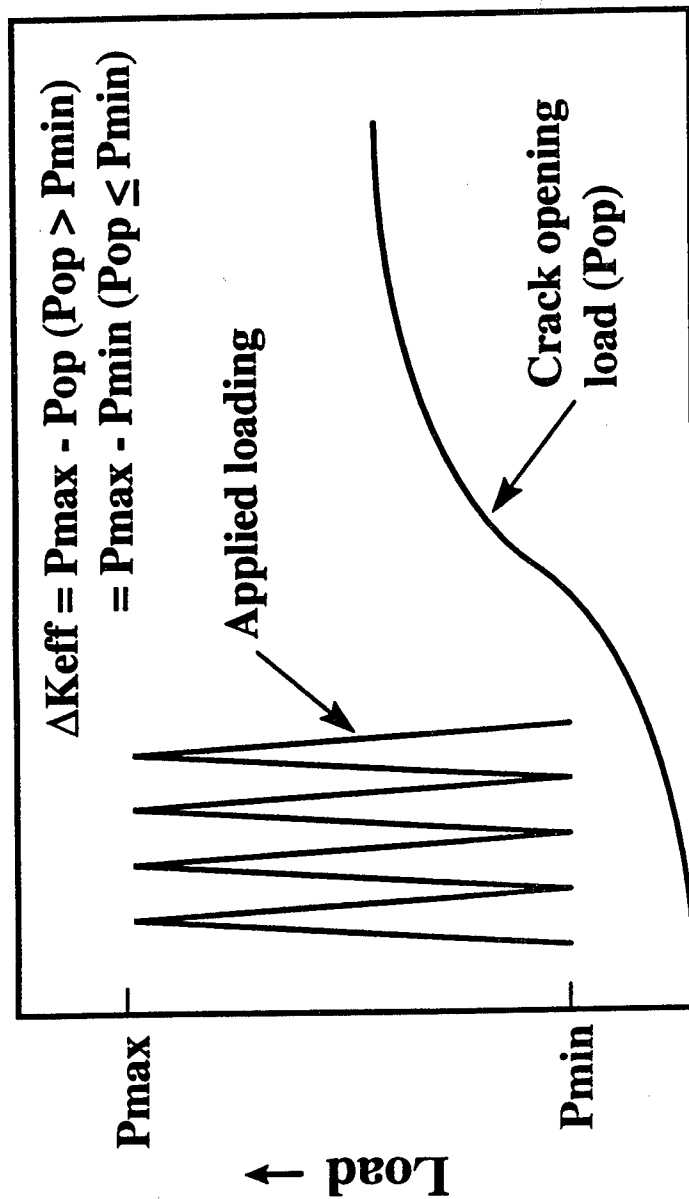
Evaluation of small crack growth requires closure free FCGR data.

Crack opening load transition with crack evolution and growth

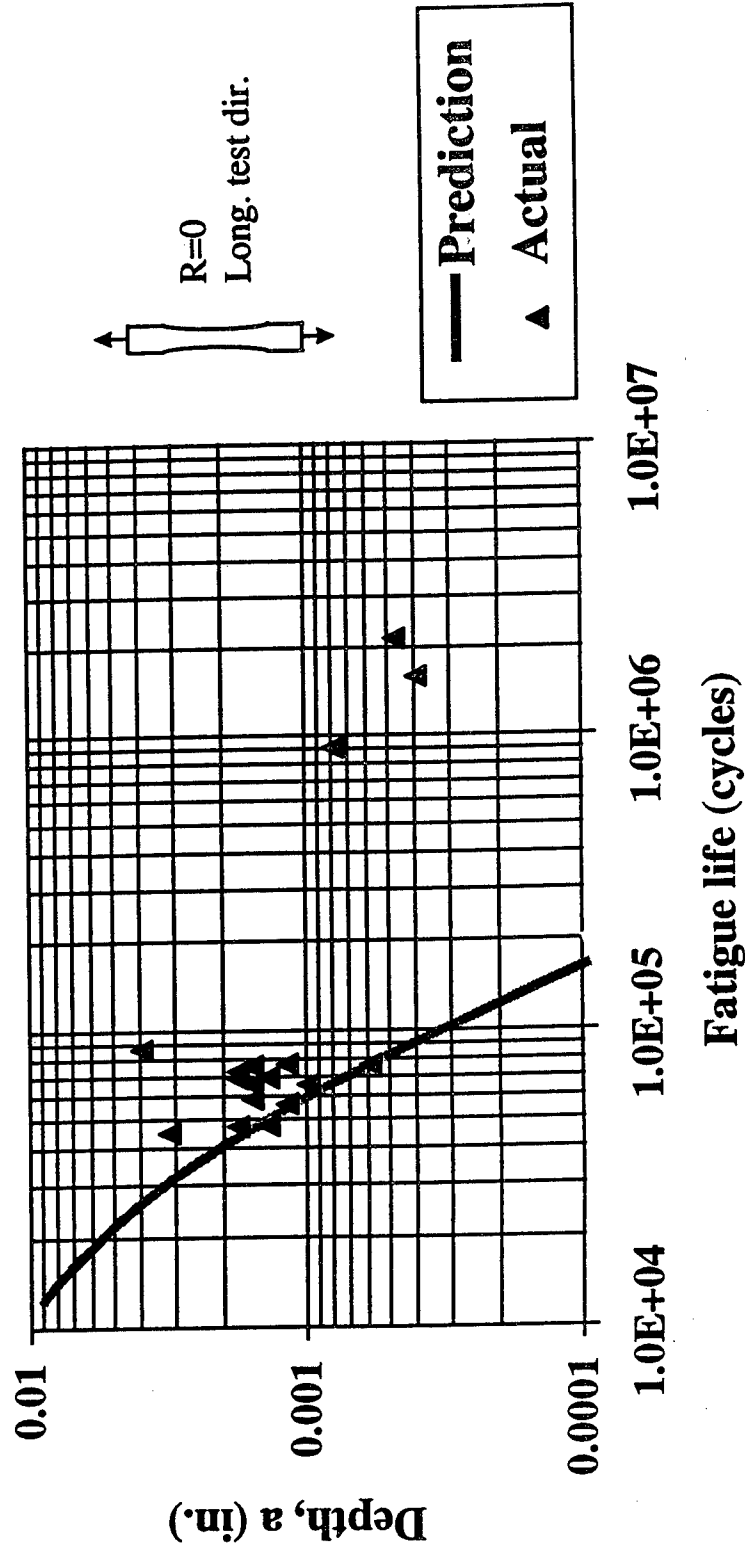
35 ksi: microfeature depth vs. cyclic life

7150-T77511 extrusion with surface IGC
